INDOOR AIR QUALITY ASSESSMENT

**Ayer District Court
25 East Main Street
Ayer, Massachusetts**

Prepared by:
Massachusetts Department of Public Health
Bureau of Environmental Health
Indoor Air Quality Program
December 2018

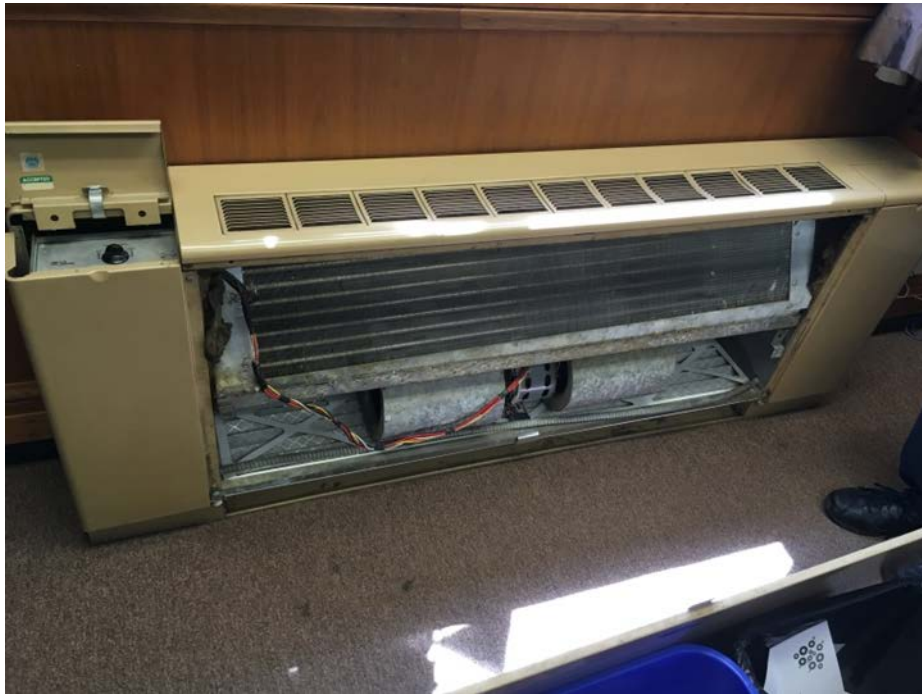
Picture 1

Fresh air to the ADC is provided by an HVAC system located in a mechanical space through ducted vents. Fan coil units (FCU) in rooms recirculate air, filter it, and provide heating and cooling but do not provide a source of fresh air (Picture 1).

Fan coil unit (FCU)

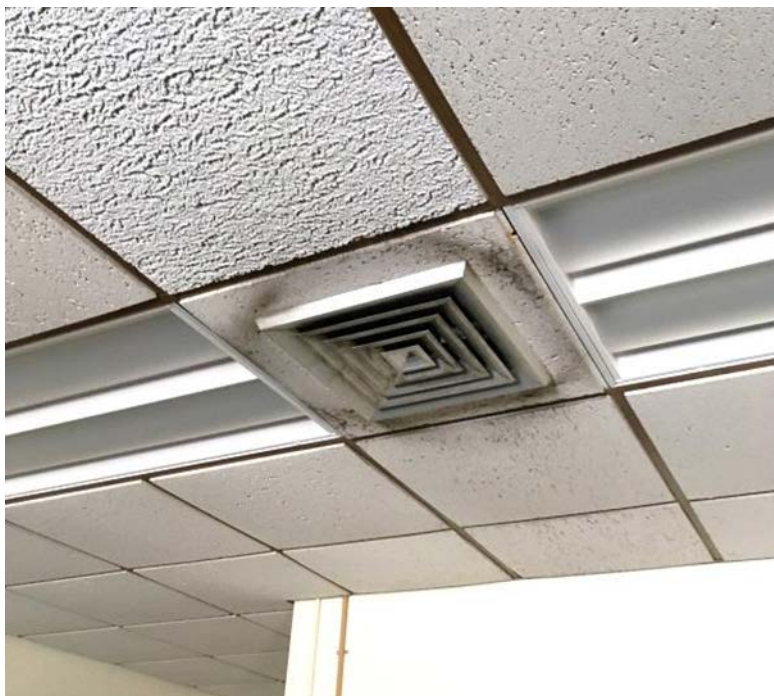
Picture 2

Of note were concerns regarding dust and debris building up on flat surfaces (Picture 2). The HVAC system was originally equipped with a filter system that was mounted on rollers that slowly unrolled the filter medium over the opening to the AHU coils. The roller system is operating. Filter medium is currently cut from bulk rolls and placed over the opening to the AHU coils. This filter system provides minimal filtration of outdoor air with the filter in place, and no filtration if the filter is not in place. In addition, the filter medium needs to be physically cut to size which may be subject to poor fit. MDPH recommends tight-fitting filters of a Minimum Efficiency Reporting Value (MERV) of 8, which are adequate in filtering out pollen and mold spores (ASHRAE, 2012). Lack of filtration would likely account for the noted dust and debris on flat surfaces reported by building occupants.

Stained ceiling tile

3. Remove, replace and/or reduce the number of materials in the lock-up that are capable of supporting mold growth.
4. Consider installing a filter rack system in the fresh-air intake opening in place of the current filter roller system.

5. Once the filter rack is installed, use appropriate filters with a rating of MERV 8 or higher.
6. Given that the HVAC system appears to have had minimal filtration, it may be advised to have the interior of the duct system cleaned. The ductwork should be cleaned in a manner consistent with recommendations and guidance set by the National Air Duct Cleaners Association (NADCA).

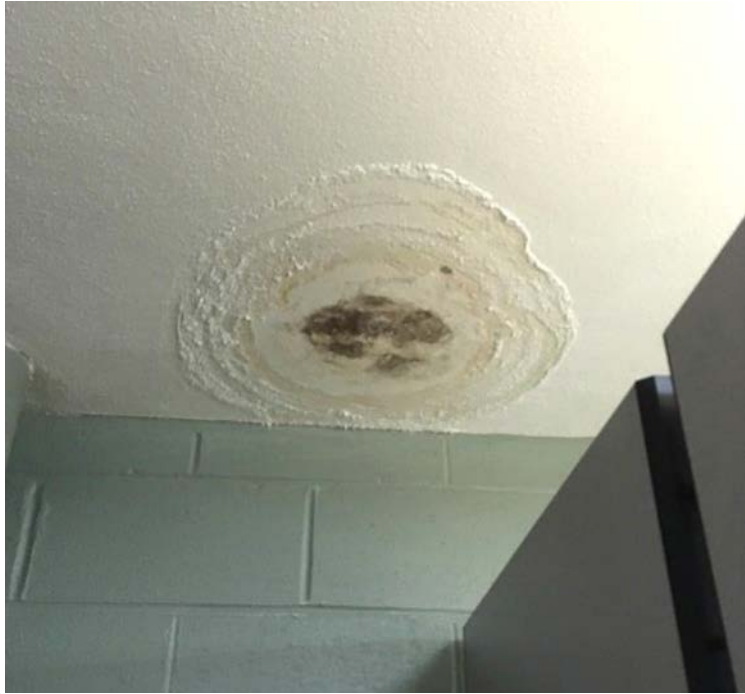
Water-damaged ceiling tiles and ceiling plaster were observed in a few areas. One area had water-damaged paint on plaster colonized with mold (Picture 3). This condition indicates the existence leaks from the building envelope or plumbing system that should be repaired. The United States Environmental Protection Agency (US EPA) and the American Conference of Governmental Industrial Hygienists (ACGIH) recommend that porous materials be dried with fans and heating within 24 to 48 hours of becoming wet (US EPA, 2008; ACGIH, 1989). If porous materials are not dried within this time frame, mold growth may occur. Once mold has colonized porous materials, they are difficult to clean and should be removed and discarded.

With the exception of the area in Picture 3, no visible mold growth was observed during this assessment. As mentioned, some areas had water-damaged ceiling tiles (Table 1) but none of the stained tiles appeared to be colonized by mold. Water-damaged ceiling tiles should be replaced once the source of water (e.g., condensation, plumbing or roof leaks) has been repaired. Water-damaged ceiling tiles if chronically exposed to a moisture source can become mold colonized. Exposure to mold can cause respiratory irritation as well as exacerbation of asthma symptoms.

Mold-contaminated plaster/paint in janitor's closet in basement

7. Clean mold from ceiling plaster shown in Picture 3 and repair the source causing this water damage.
8. Replace water-damaged and stained ceiling tiles as needed.

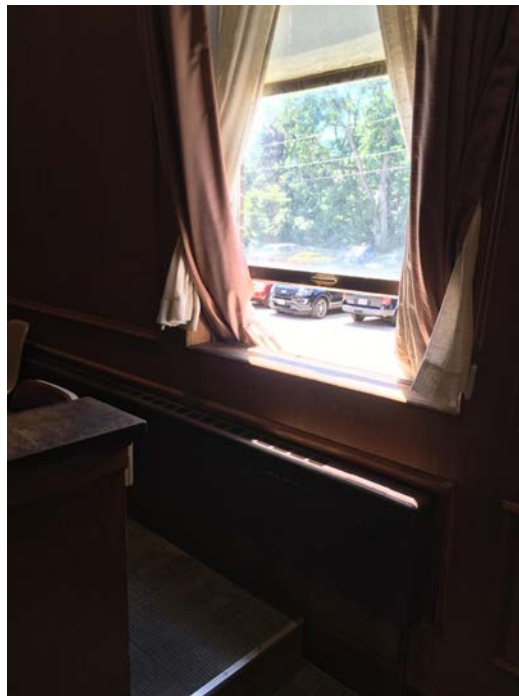
Picture 4

As noted previously, the building has openable windows. During the course of this assessment, an open window (Picture 4), with curtains hanging through the window to the outdoors (Picture 5) was observed in First Session court room, while the HVAC system was

operating in the cooling mode. It is not recommended to open windows when the HVAC system is in cooling mode because this allows for hot, humid air to enter the building. This condition can result in the accumulation of condensation on cold surfaces that have a temperature below the dew point of the hot, humid air, which can cause mold growth. In addition, outdoor microbial particles, including mold and mold spores, can be drawn into the building, bypassing the HVAC filter system.

Window open in First Session courtroom

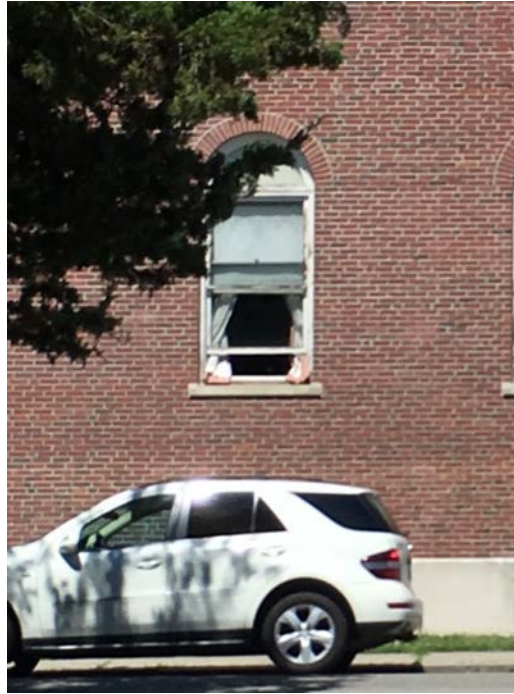
Picture 5

Curtains outside building

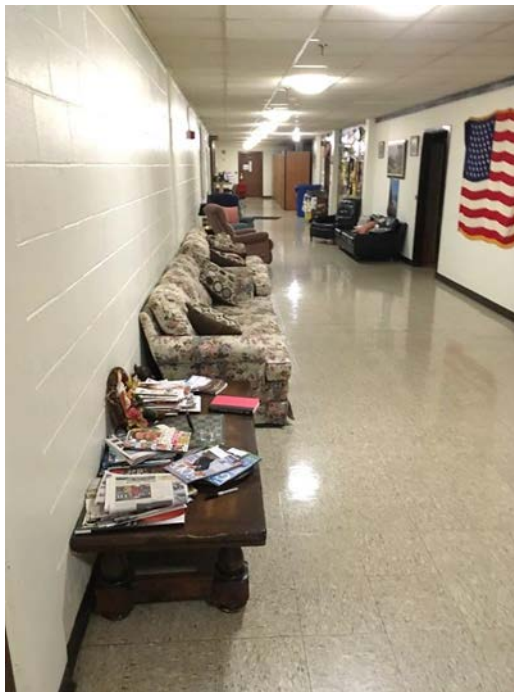
Picture 6

Upholstered furniture was observed in several areas (Picture 6; Table 1). These items are covered with fabrics that may be exposed to human skin. This type of contact can leave oils, perspiration, hair and skin cells. Dust mites feed upon human skin cells and excrete waste products that contain allergens. In addition, if relative humidity levels increase above 60 percent, dust mites tend to proliferate (US EPA, 1992). In order to remove dust mites and other pollutants, frequent vacuuming of upholstered furniture and plush toys is recommended (Berry, 1994). It is also recommended that upholstered furniture be professionally cleaned on an annual

Upholstered furniture in basement

basis. Where an excessively dusty environment exists due to outdoor conditions or indoor activities (e.g., renovations), cleaning frequency should be increased (every six months) (IICRC, 2000).
